CULTURAL RESOURCE MANAGEMENT PLAN

Fayette Historic Townsite

Delta County, Michigan

Final Submission
December 1996

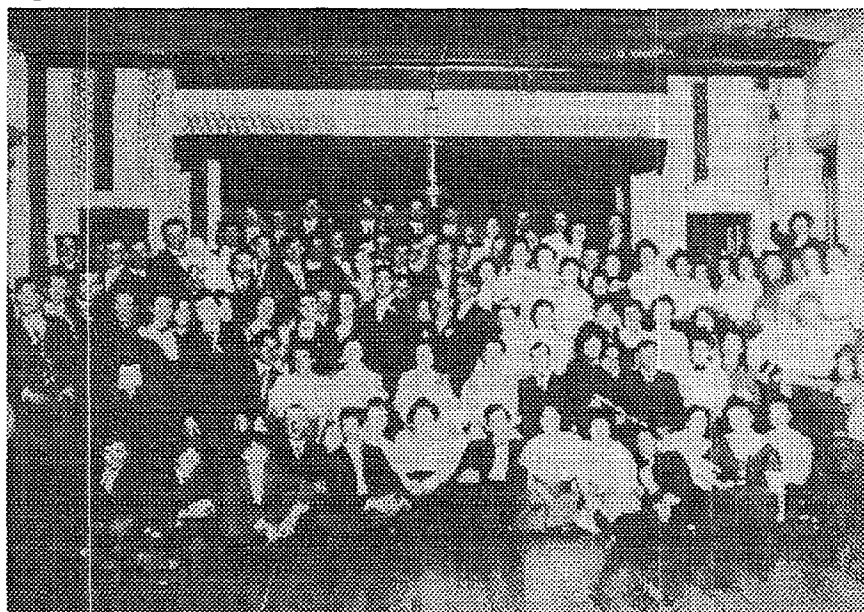
Figure III-12

*Interior view of the second floor of the Town Hall (Building #101).
Note: The decorative hangings along stage wall; plaster damage at the ceiling and the wall at the northeast corner of the room.
Date: ca. 1908*

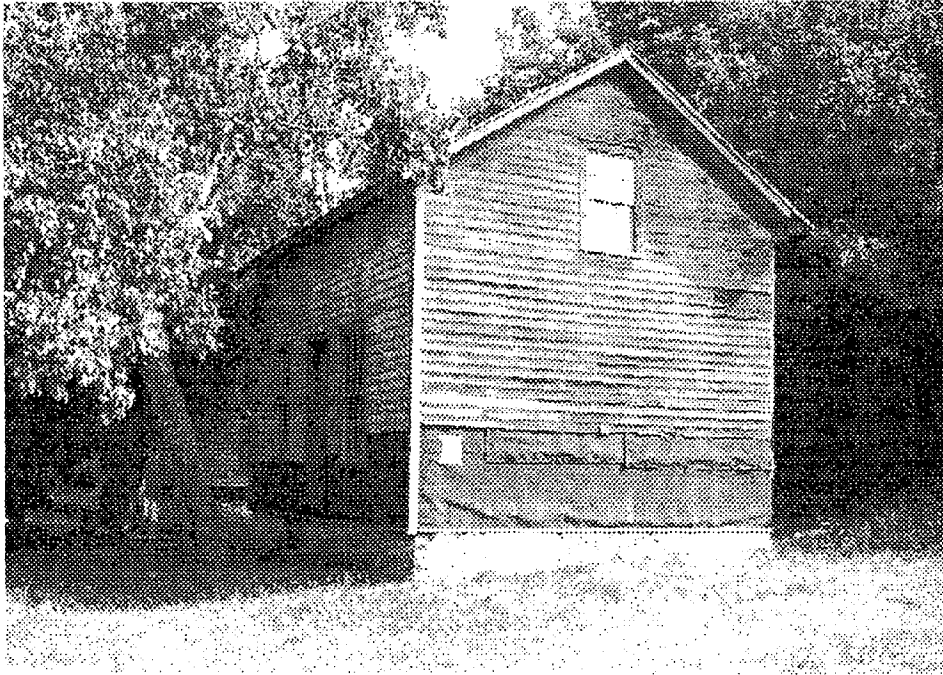
Figure IV-7

*View of one the Supervisor's Residences (Bldg. #25) following stabilization work by the park.
Note: The deteriorated sill plate has been replaced, awaiting new clapboard installation.
Date: ca. 1960 - 1970*

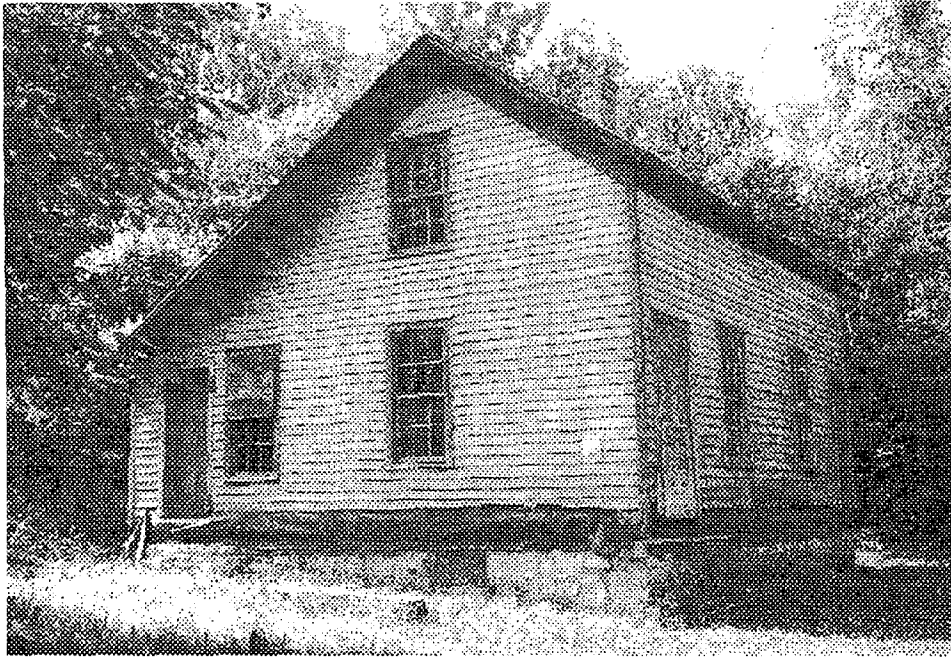
Figure IV-11

*View of the only remaining Supervisors' Duplex Residence (Bldg. #30/31). (There were originally four duplexes constructed at Fayette.
Note: The deteriorated sill plate has been replaced by the park; awaiting new clapboard siding.
Date: ca. 1960 - 1970)*

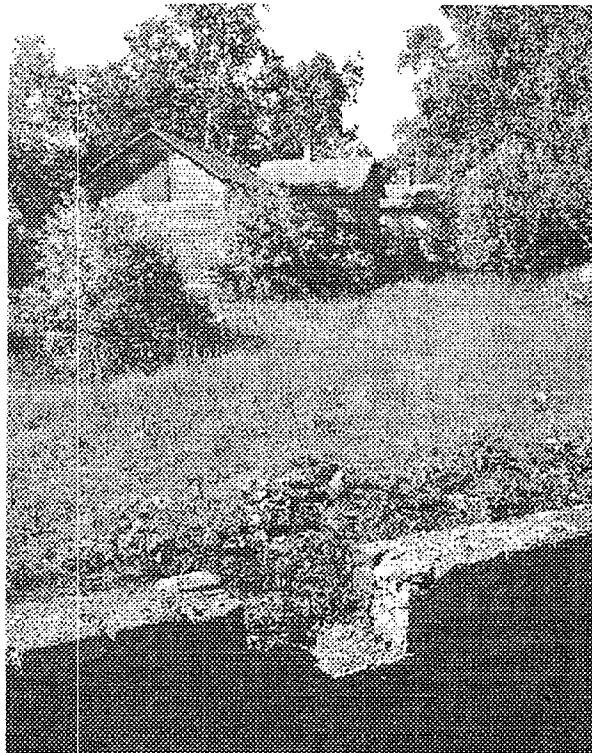
Figure IV-13

*View looking toward rear of Buildings #25 and #26.
Note: Deteriorated foundation in foreground;
Date: ca. early 1960s*

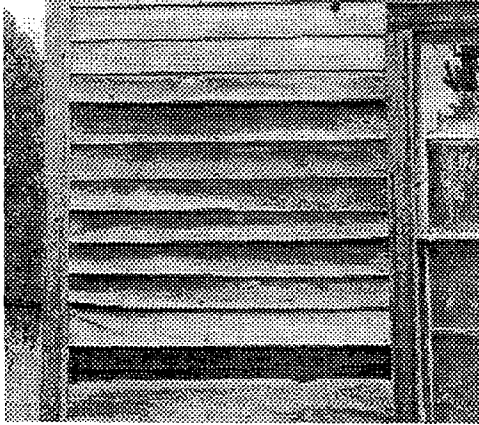
Figure 13

Detail view of deteriorated clapboard siding, which is present at different levels at each of the buildings, 1996.

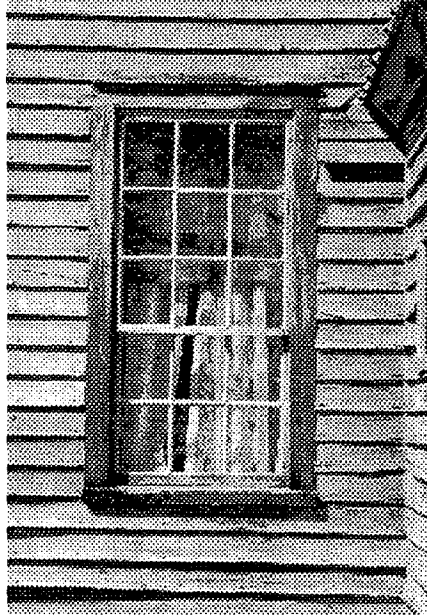
Figure 14

Detail view of a nine-over-six double-hung window, typical at several of the Supervisor's Residences throughout the townsite, 1996. Wood deterioration has been the result of the lack of protective finish.

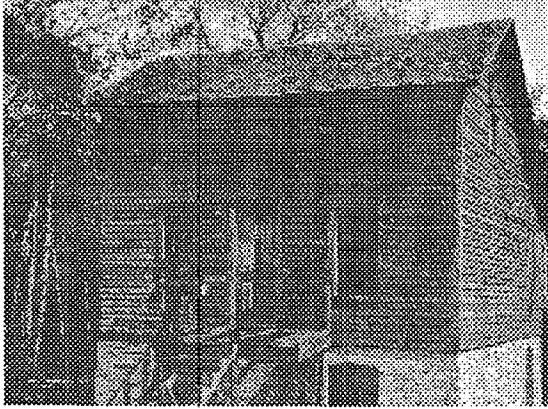
Figure 21

View of the south elevation in 1907. Note the exterior stair has extensively deteriorated.

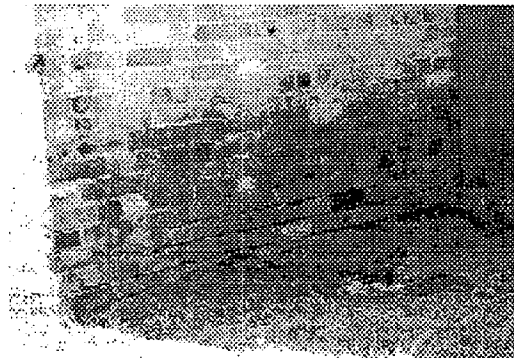
Figure 24

Detail view of the deteriorated (missing) mortar joints at the north elevation, 1996..

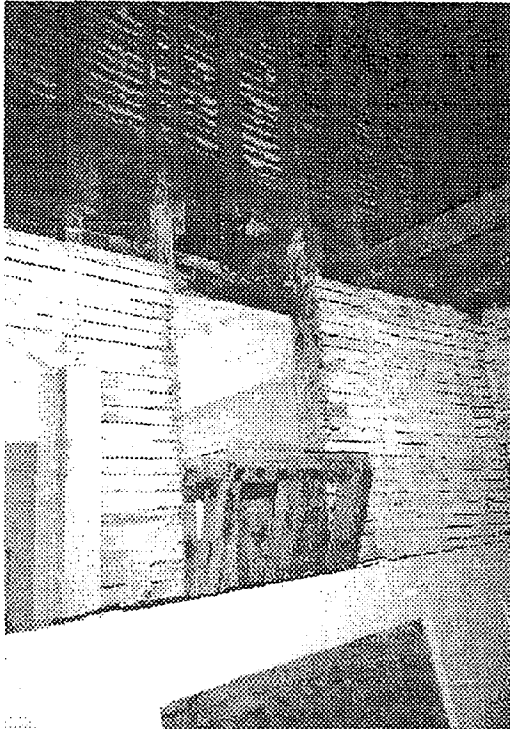
Figure 28

Detail view of the wood framing that previously supported the former chimney, 1996. Note that the entire ceiling / floor structure above is missing.

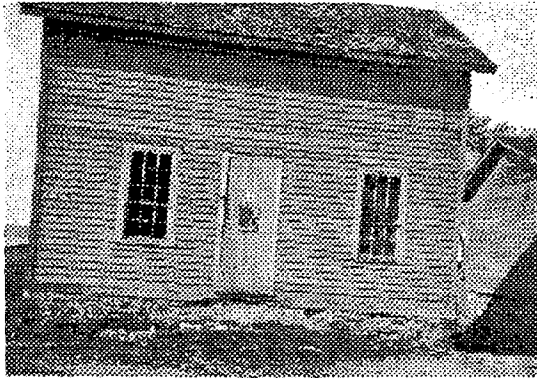
Figure 34

View of the north elevation in 1907. Note that the porch is missing and the foundation has deteriorated. Note the (presumed non-historic) plank door.

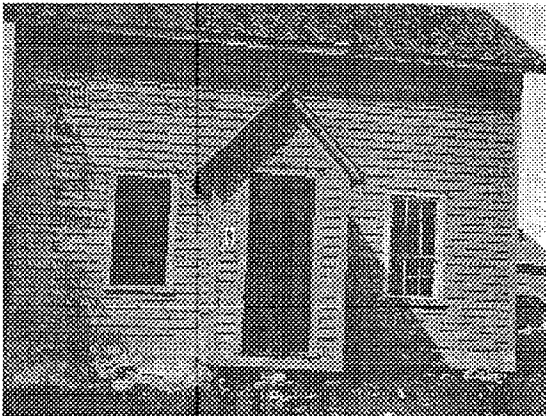
Figure 37

View of the north elevation, ca. 1907. Note that most of the paint has worn off the exterior of the building, the porch steps have deteriorated and are missing, and the window sash is missing from one of the windows.

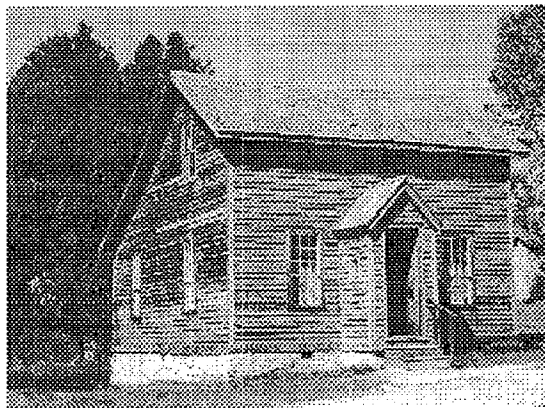
Figure 38

View of the north and east elevations, 1996. Note the reconstructed porch vestibule (it is very similar to the original in Figure 21). Note the conspicuous areas of clapboard replacement.

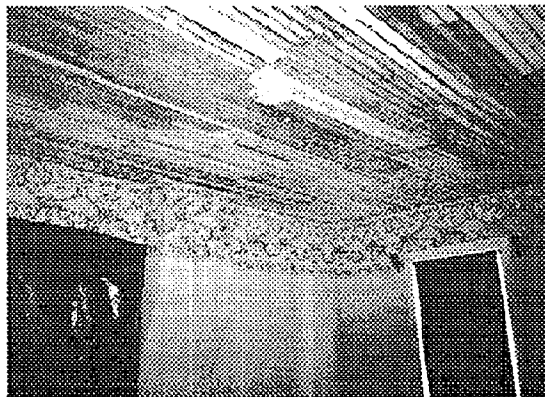
Figure 40

View of the ceiling of the dining room, 1996. This room was in the process of treatment when the photograph was taken. Note that areas of deteriorated lath have been replaced at the ceiling prior to the installation of new plaster.

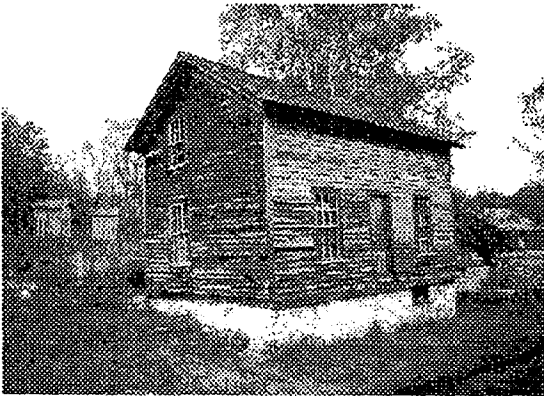
Figure 41

View of the north and west elevations. Note the several areas of deteriorated clapboard and the missing front steps. Also note the contemporary pit toilets located in the left background.

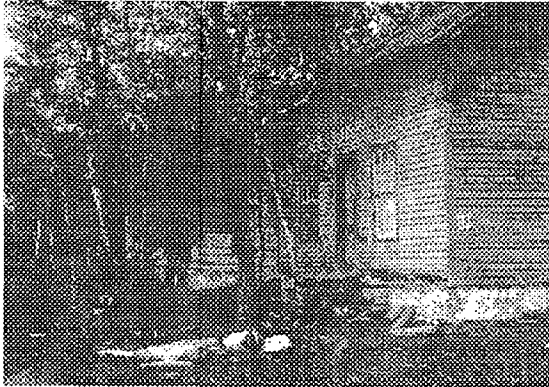
Figure 44

View of the west elevation, ca. 1907. Note the deteriorated front porch.

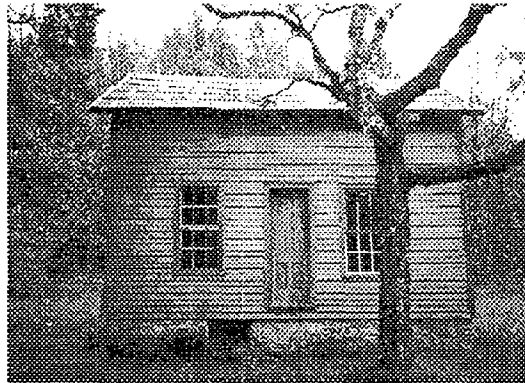
Figure 45

View of the west elevation, ca. 1907. Note that the roof is only covered with felt roofing held down with batten boards.

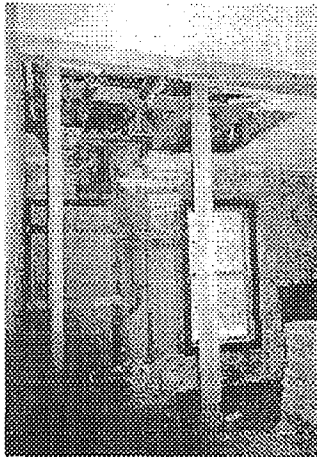
Figure 47

View of the interior looking west, 1996. Note the broken ceiling joists and temporary shoring.

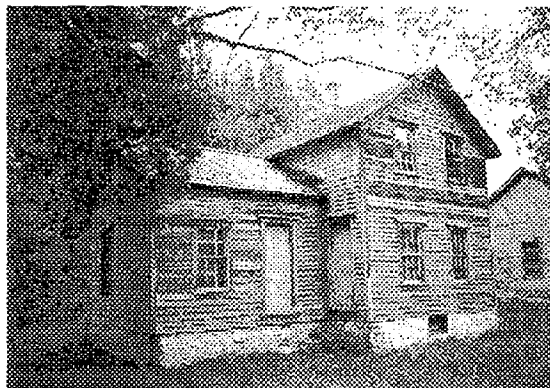
Figure 51

View of the west elevation, 1996. Note that the porch is has deteriorated and is completely gone. Also note the areas of clapboard replacement evidenced through a contrast in color.

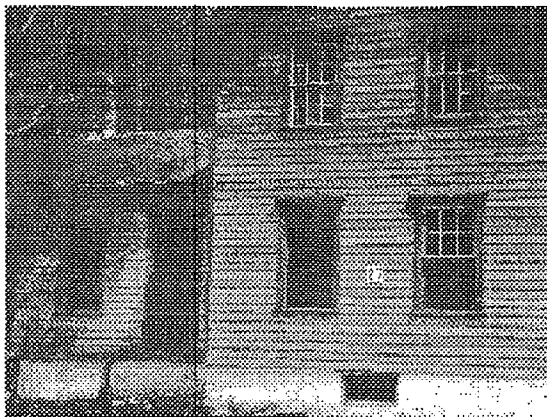
Figure 55

View of the west elevation, ca. 1907. Note that the stair has either deteriorated or was removed. Also note that most of the paint finish has worn off of the building.

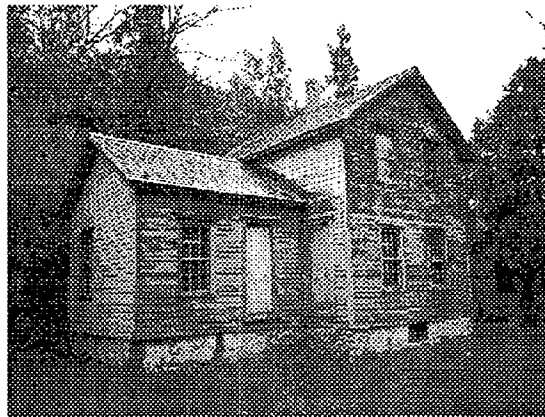
Figure 56

View of west and north elevations, 1996. Note the areas of deteriorated clapboard siding.

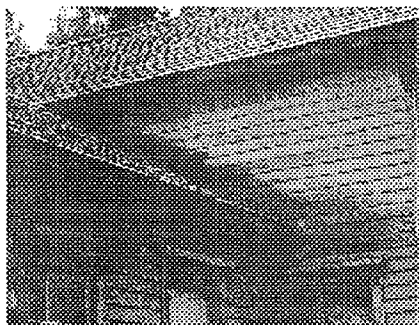
Figure 58

Detail view of the mildew-stained clapboard along the roof connection, 1996. Moisture accumulation has been a problem at several of the structures due to the lack of ventilation, overgrowth of vegetation, and lack of sunlight.

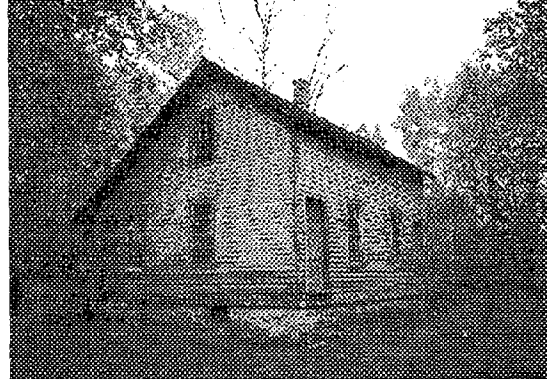
Figure 61

View of the west and north elevations, 1996. Note the areas of deteriorated clapboard siding and that the wood steps at each of the entrances are gone.

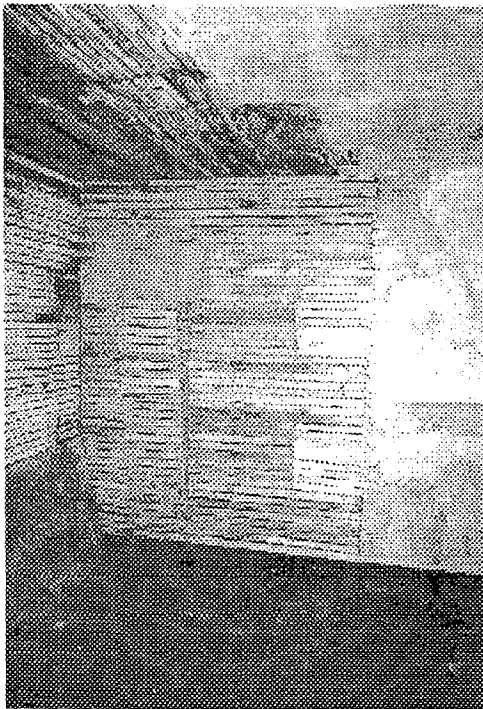
Figure 62

View of the interior at the rear of the building, 1996. An extensive amount of repair was undertaken along the entire rear of the house, including: sill and framing replacement as necessary, finish flooring replacement, and lath and plaster replacement.

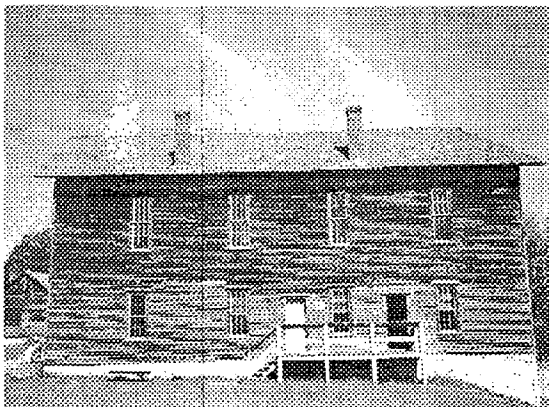
Figure 66

View of the east elevation, 1996. Note the extensive areas of clapboard deterioration and that the platform and steps have been reconstructed at the entrances.

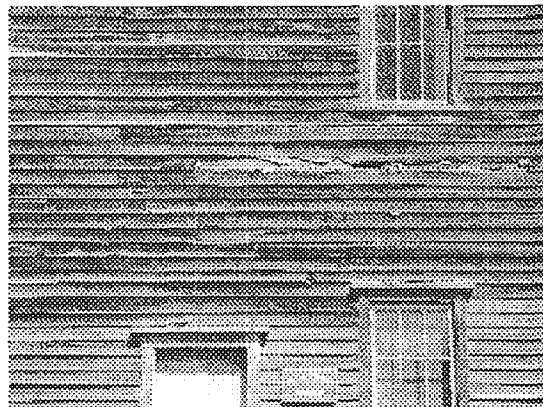
Figure 67

Detail view of deteriorated clapboard at the east elevation, 1996.

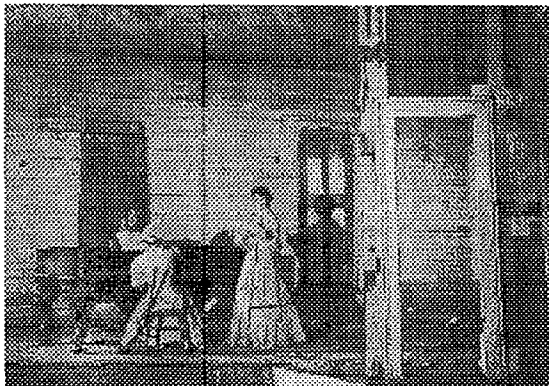
Figure 68

Interior view of the second floor auditorium / meeting space, looking toward the stage, ca. 1960s. The space has experienced extensive deterioration and damage.
